A CULTURAL LANDSCAPE REPORT FOR HYDE HALL NATIONAL HISTORIC LANDMARK

A THESIS
PRESENTED TO THE FACULTY OF THE GRADUATE SCHOOL
OF CORNELL UNIVERSITY
IN PARTIAL FULFILLMENT OF THE REQUIREMENTS FOR THE DEGREE OF
MASTER OF ARTS

BY
WILLIAM NEIL MARZELLA
AUGUST 2011

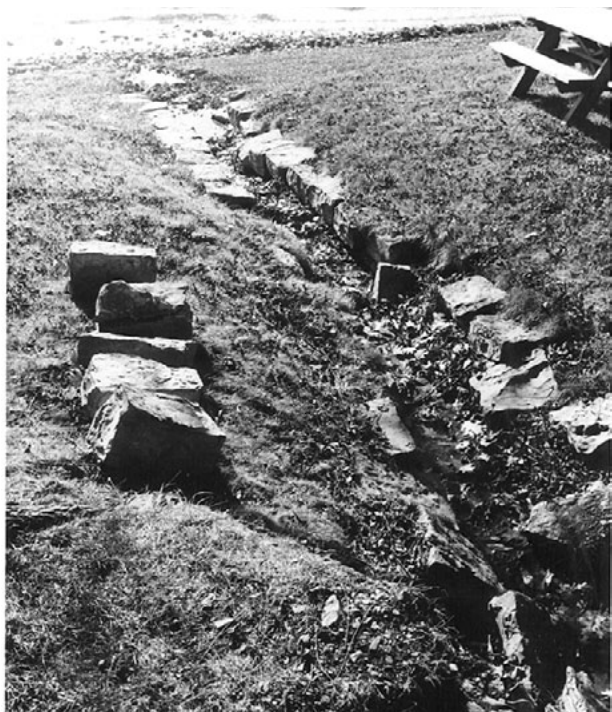
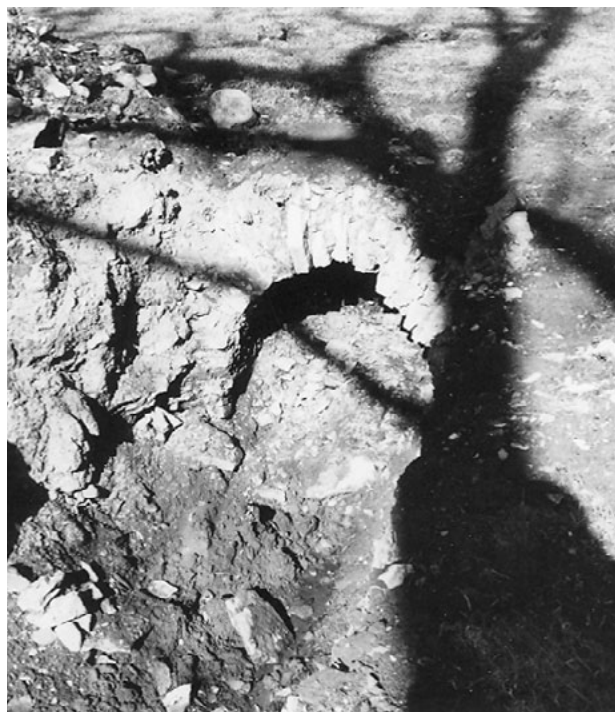
Figures 1.61 & 1.62: Photographs taken during the excavation and repair of the lower stone culvert, 1972 (courtesy NYS OPRHP)

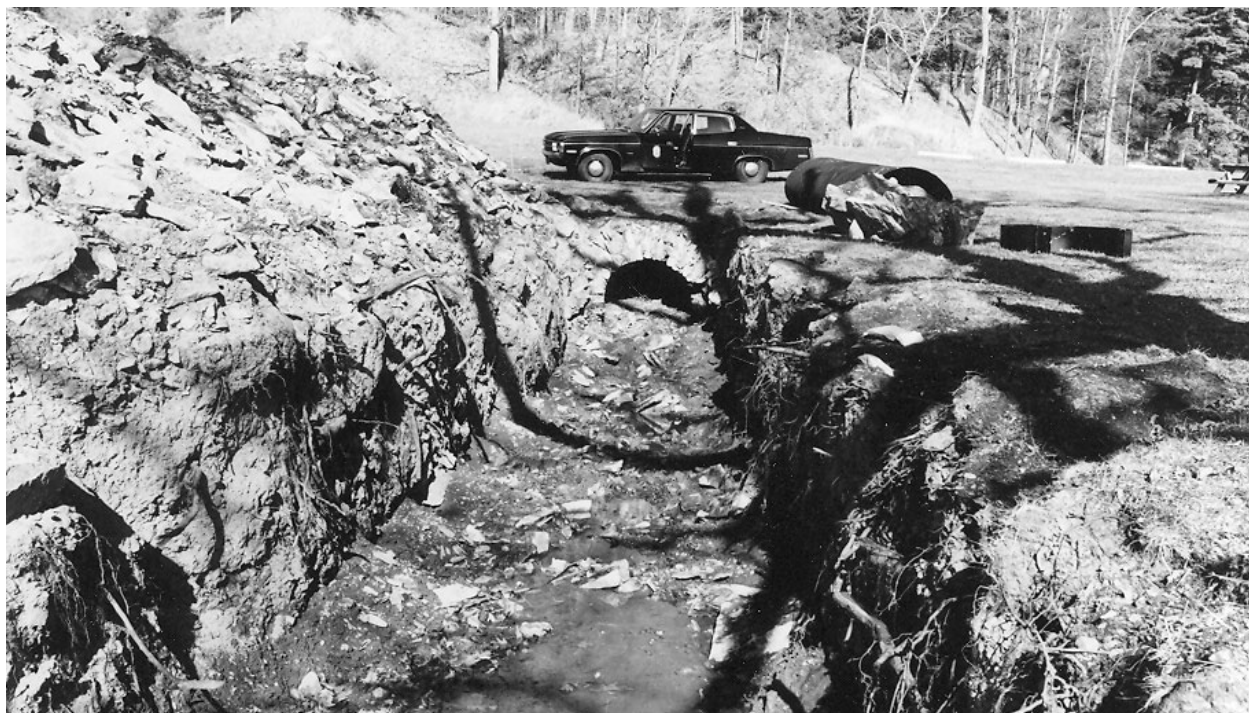
Figure 1.63: Photograph taken during the excavation and repair of the lower stone culvert, 1972 (courtesy NYS OPRHP)

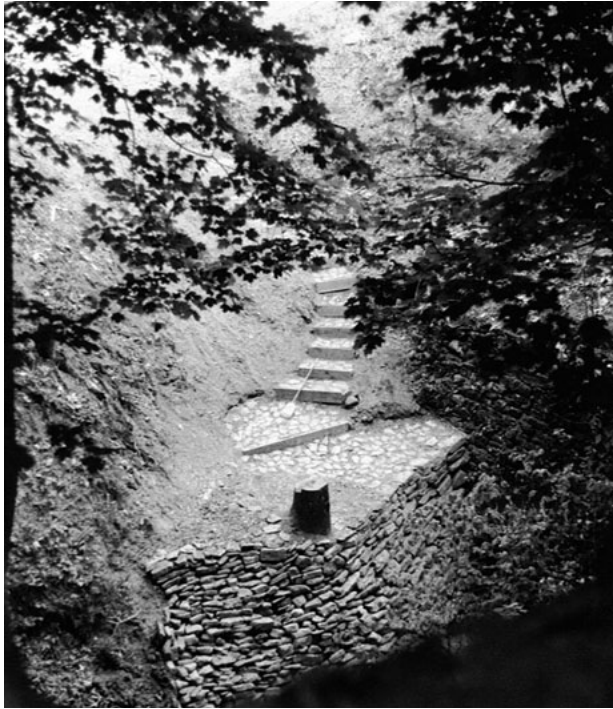
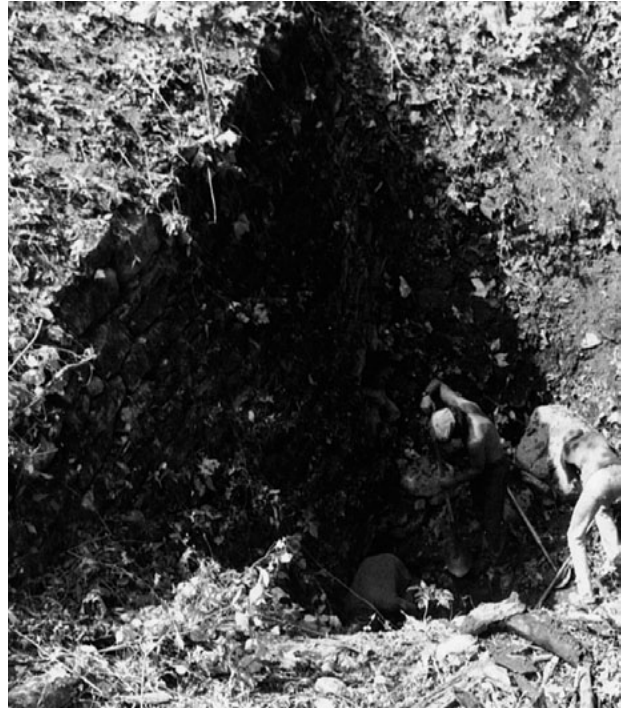
Figures 1.64 & 1.65: Photographs taken during the excavation and repair of the upper stone culvert and bridge, 1979 (courtesy Hyde Hall, Inc.)

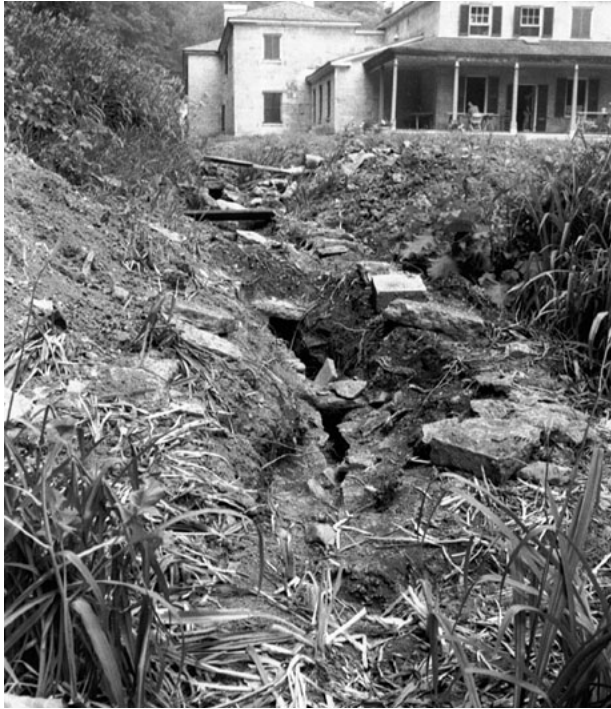
Figures 1.67 & 1.68: Photographs taken during the excavation and repair of the stone drain, 1989 (courtesy Hyde Hall, Inc.)

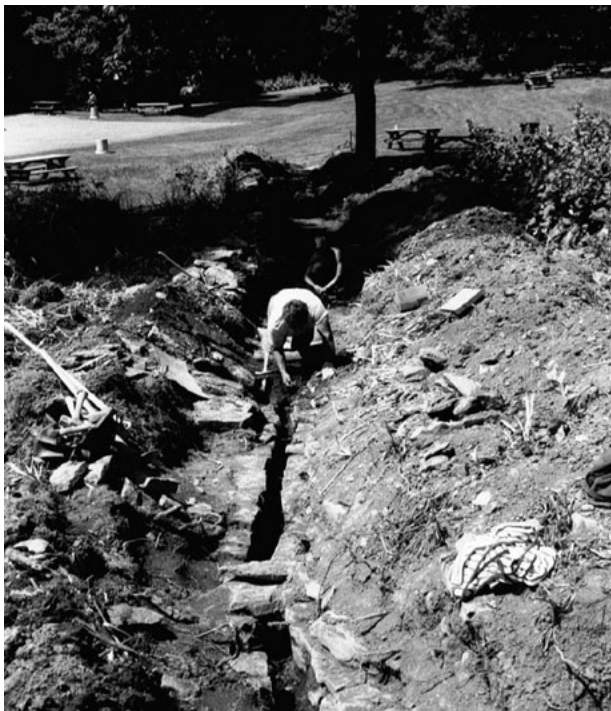
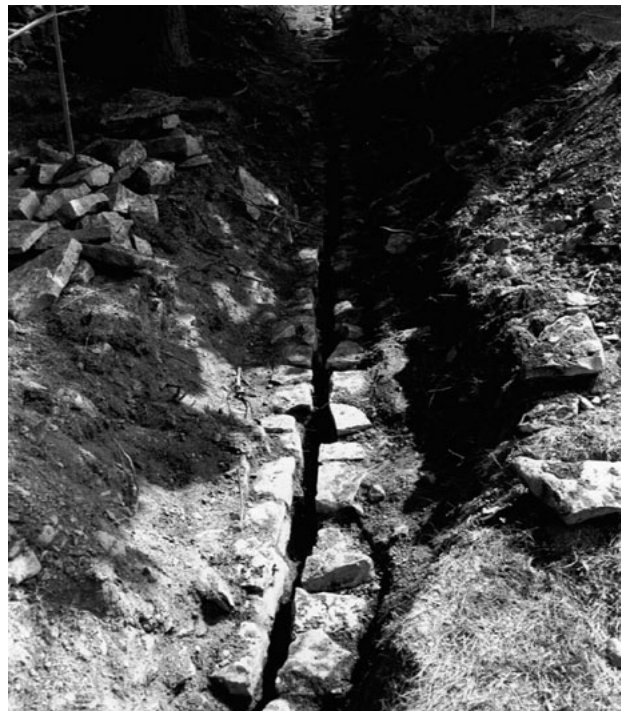
Figures 1.69 & 1.70: Photographs taken during the excavation and repair of the stone drain, 1989 (courtesy Hyde Hall, Inc.)

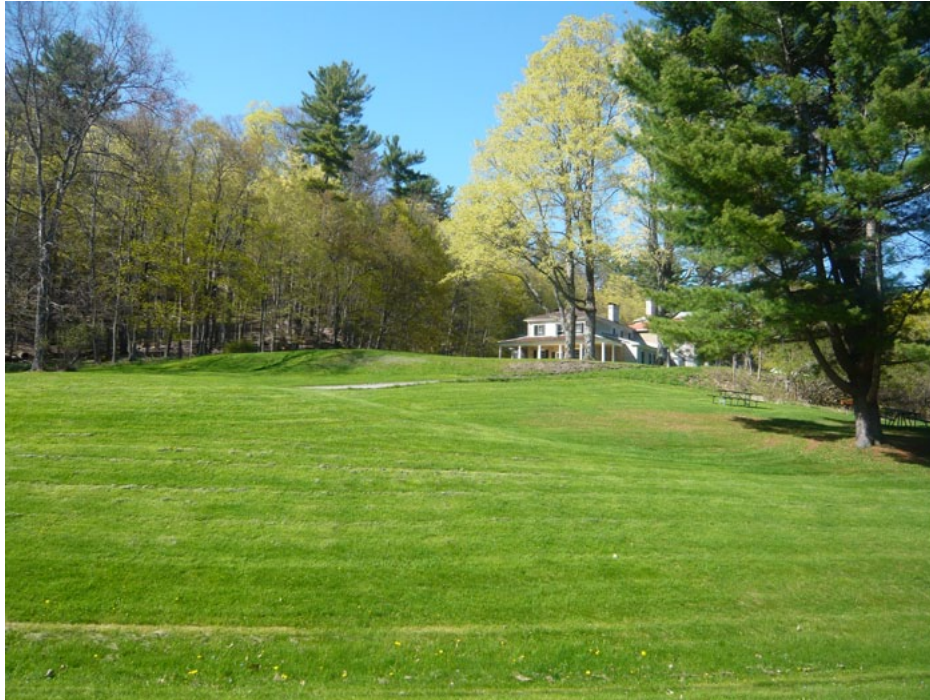
Figure 2.12: Extensive regrading around the mansion site can be observed in the present lawn

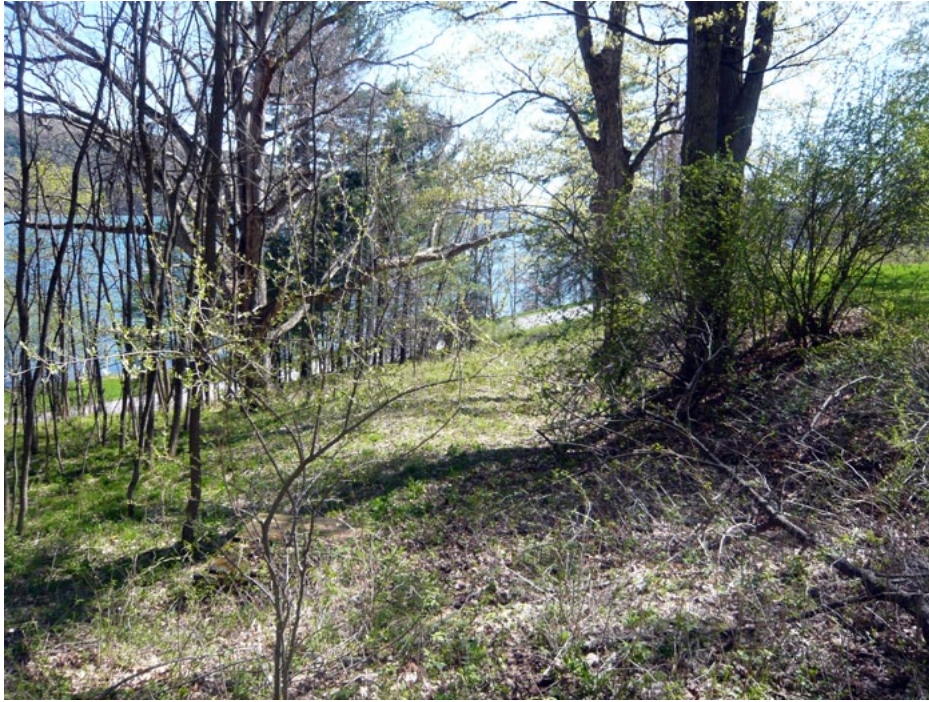
Figure 2.14: The site's lower slope has become overgrown with scrubby undergrowth

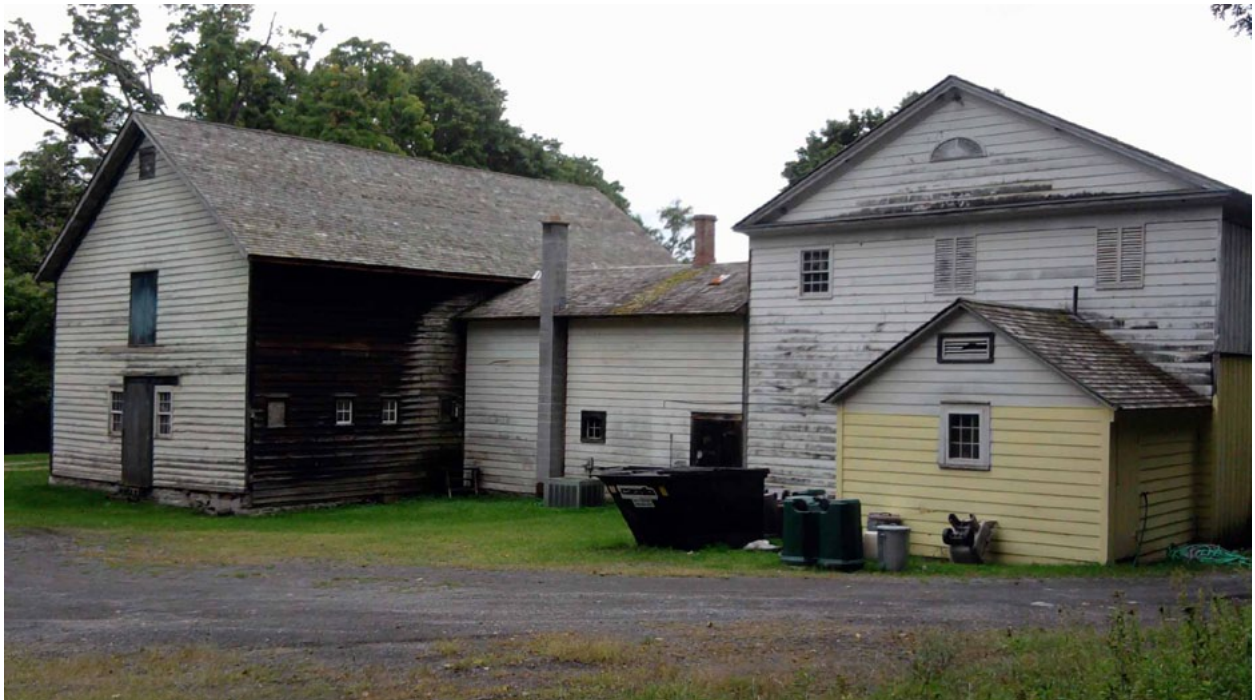
Figure 2.21: East façade of carriage house and stable, showing partially unpainted condition

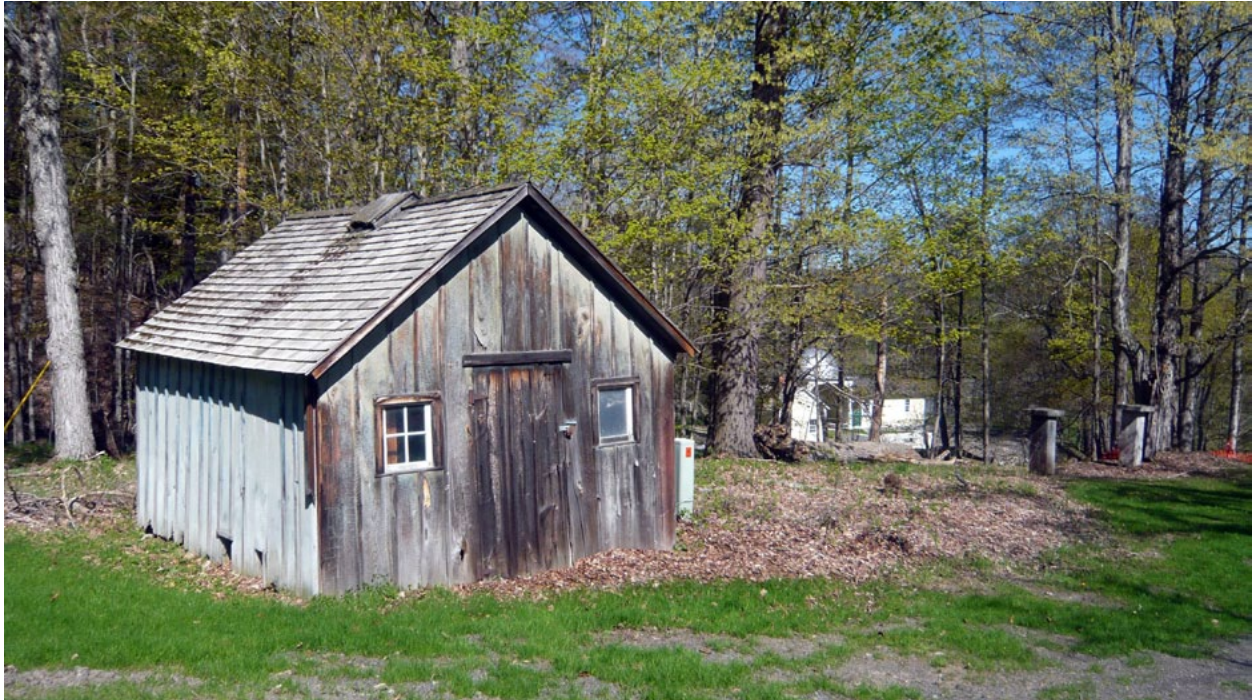
Figure 2.24: Dog kennel, showing poor exterior condition, with Tin Top faintly visible at right

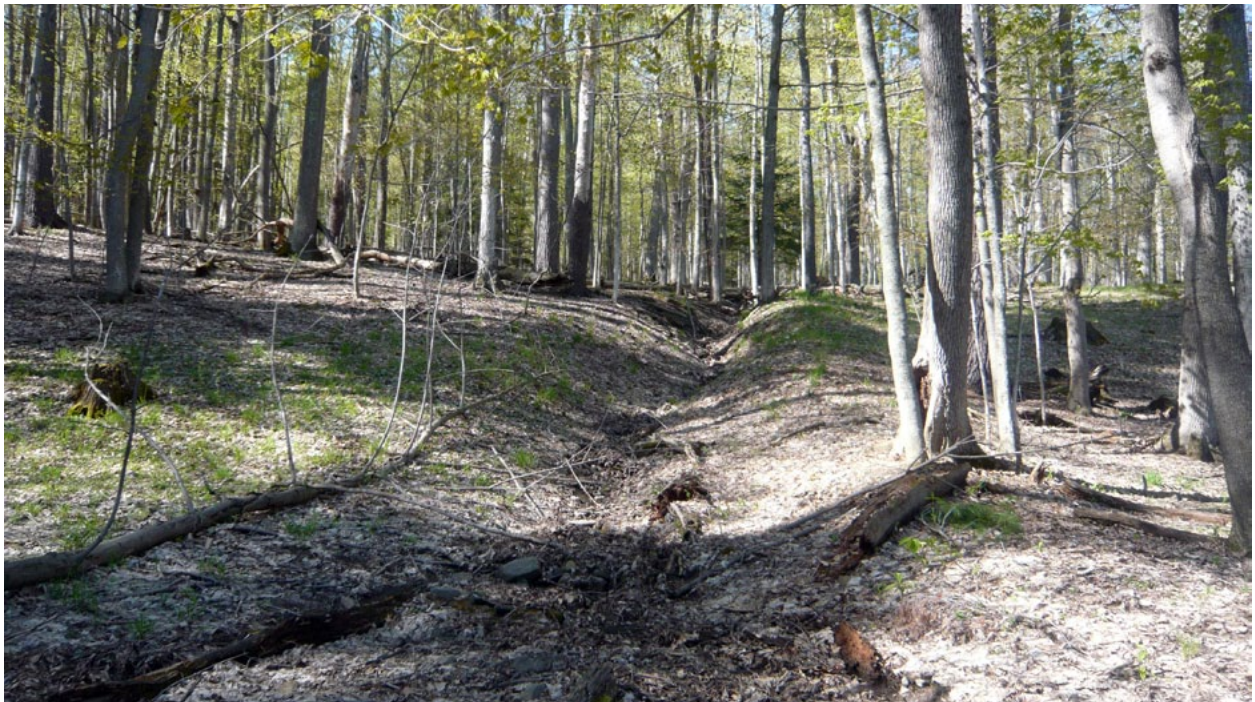
Figure 2.33: The path of the sunken fence is faintly discernible along the lower slope of Mount Wellington

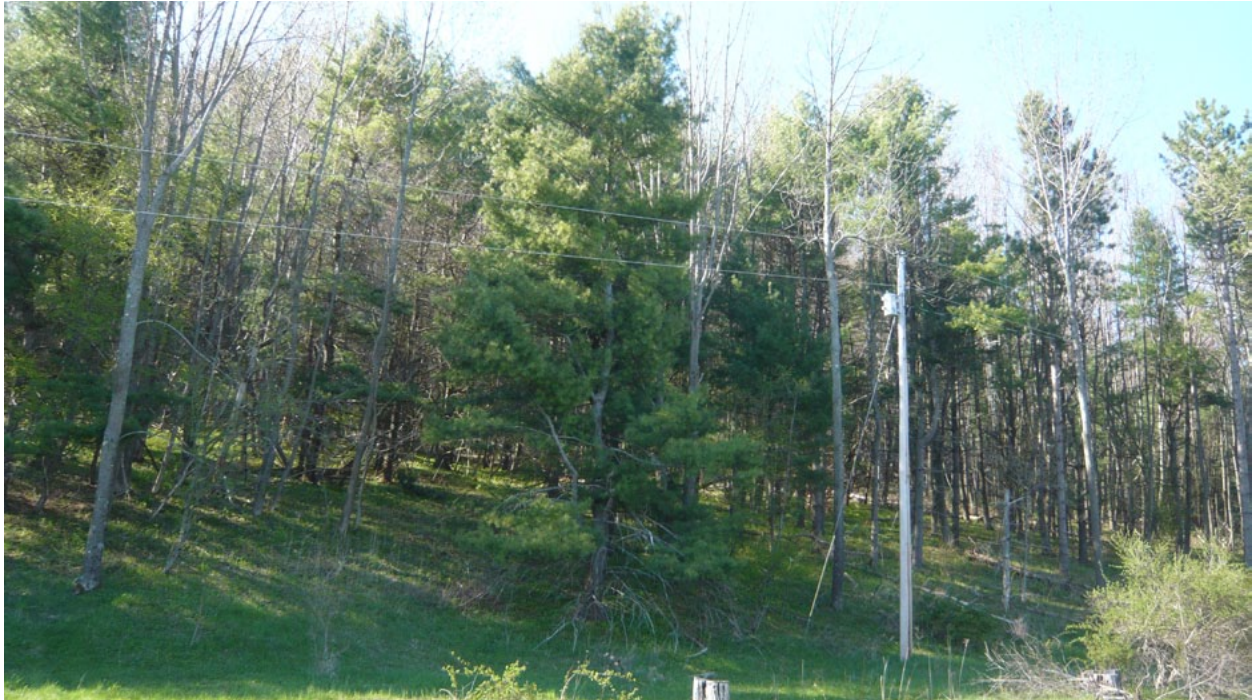
Figure 2.53: The orchard, while faintly discernible plants and rows so exist, is in a highly degraded condition

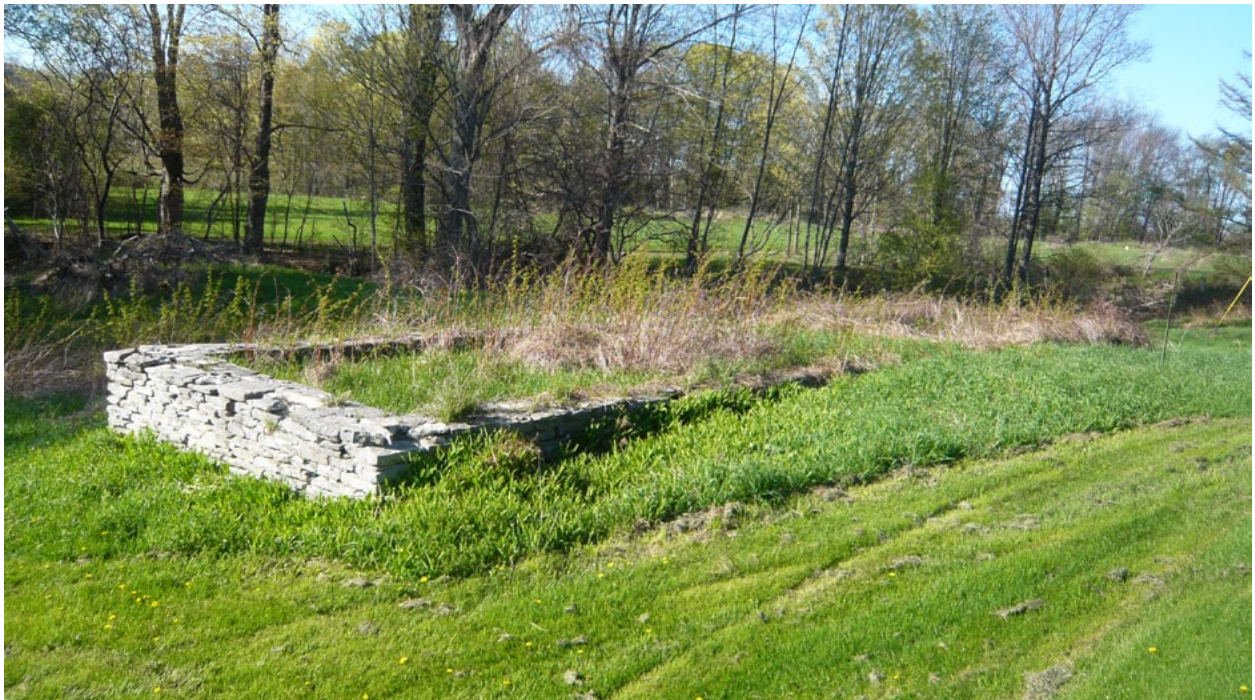
Figure 2.91: The original Tin Top Foundations are stabilized and in place, but overgrown with grasses and perennial flowers

3. Building on that theme, measures could be taken to highlight, interpret, and increase visitation to the park's other historic features. The former Tin Top foundation, for example, could be stabilized and interpreted as a ruin. Bike or walking trails could be created, following the historic approach from the main road to the mansion. The treatments could be appropriately planned and phased as resources became available.

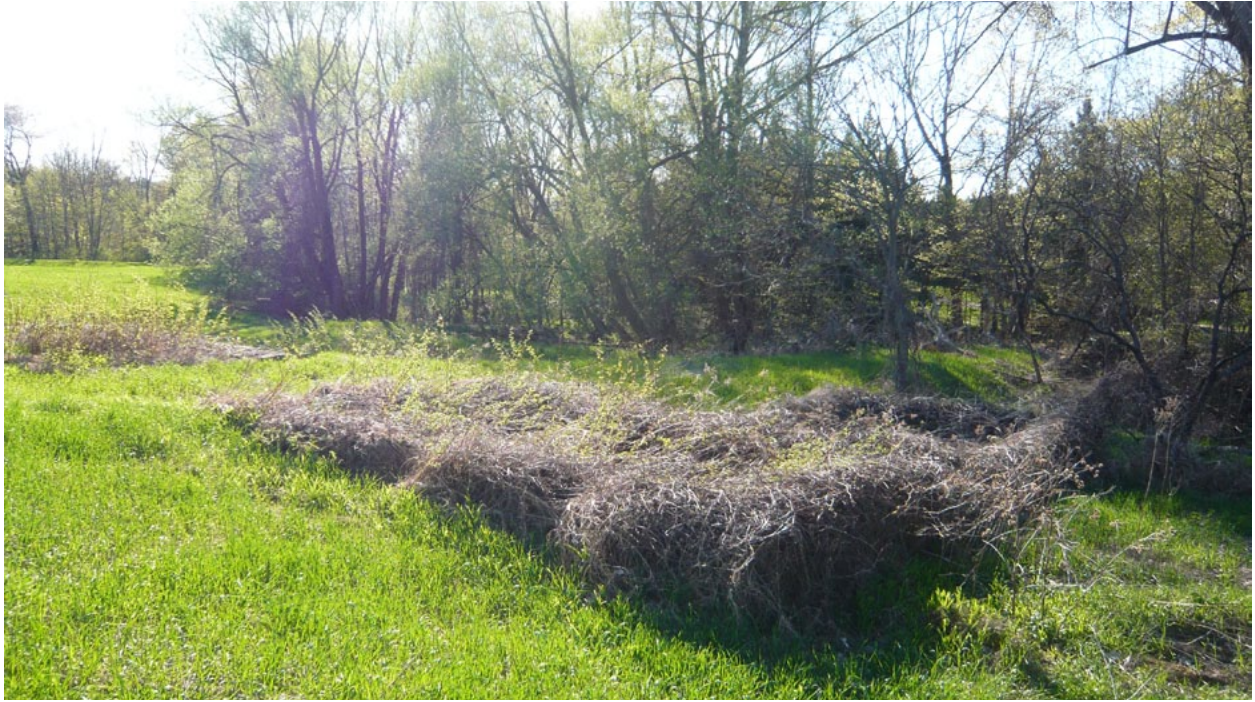
Figure 2.92: Additional view of foundations, obscured by vegetative growth

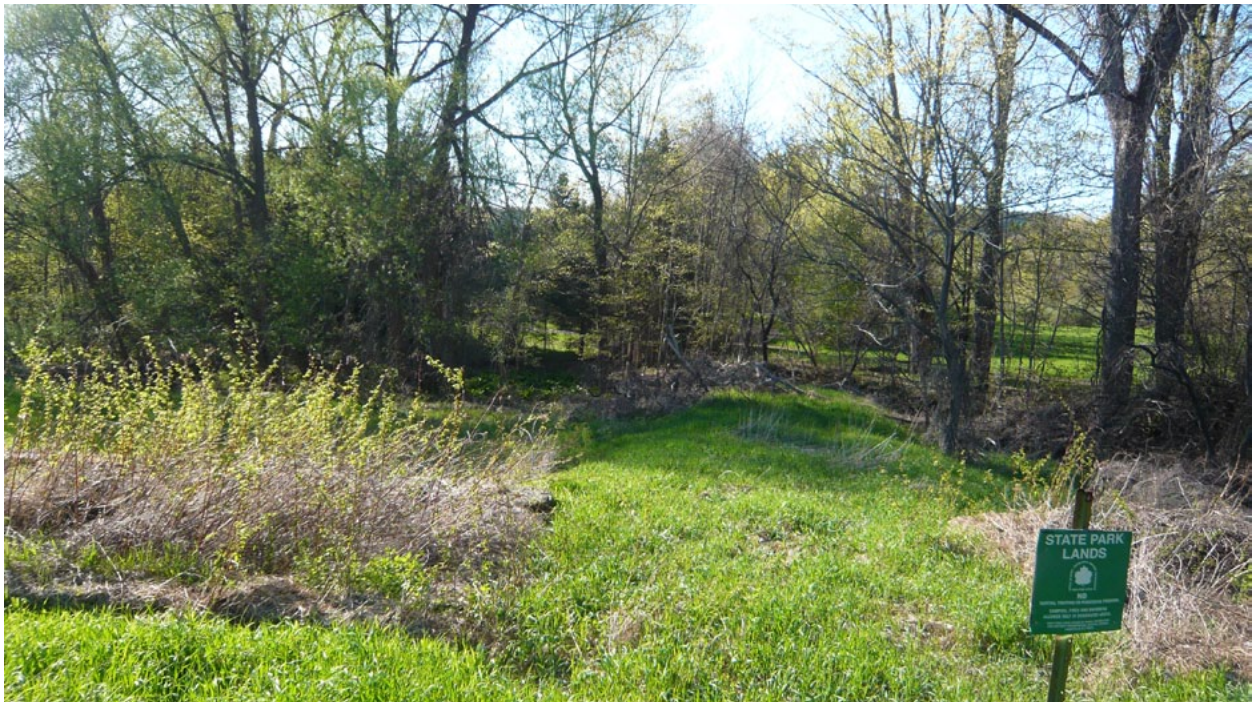
Figure 2.93: In its original condition, Tin Top was directly connected to the entry drive beyond. Currently, its foundations are severed from the extant road by a ditch

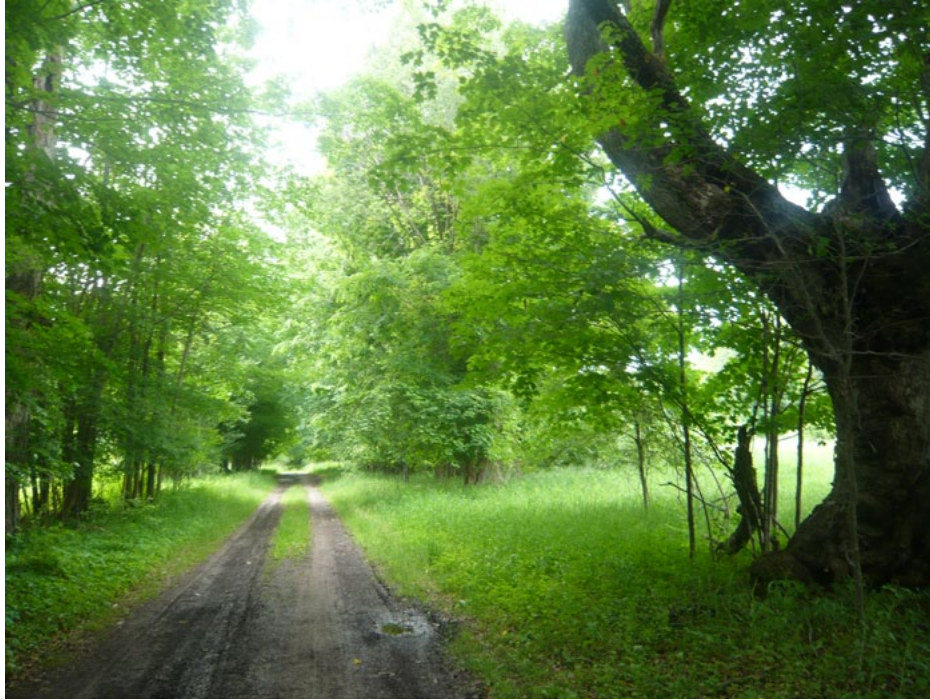
Figure 2.94: The maple avenue is a powerful feature of the landscape. It lines the original, unpaved entry drive to the estate, and retains many of its historic trees.
